Varanus Island Total Plant Shutdown Bridging Document

Bridging Document to the VI Hub Operations EP (State Waters) (EA-60-RI-00186)

PROJECT / FACILITY	Varanus Island Hub
REVIEW INTERVAL (MONTHS)	No Review Required
SAFETY CRITICAL DOCUMENT	NO

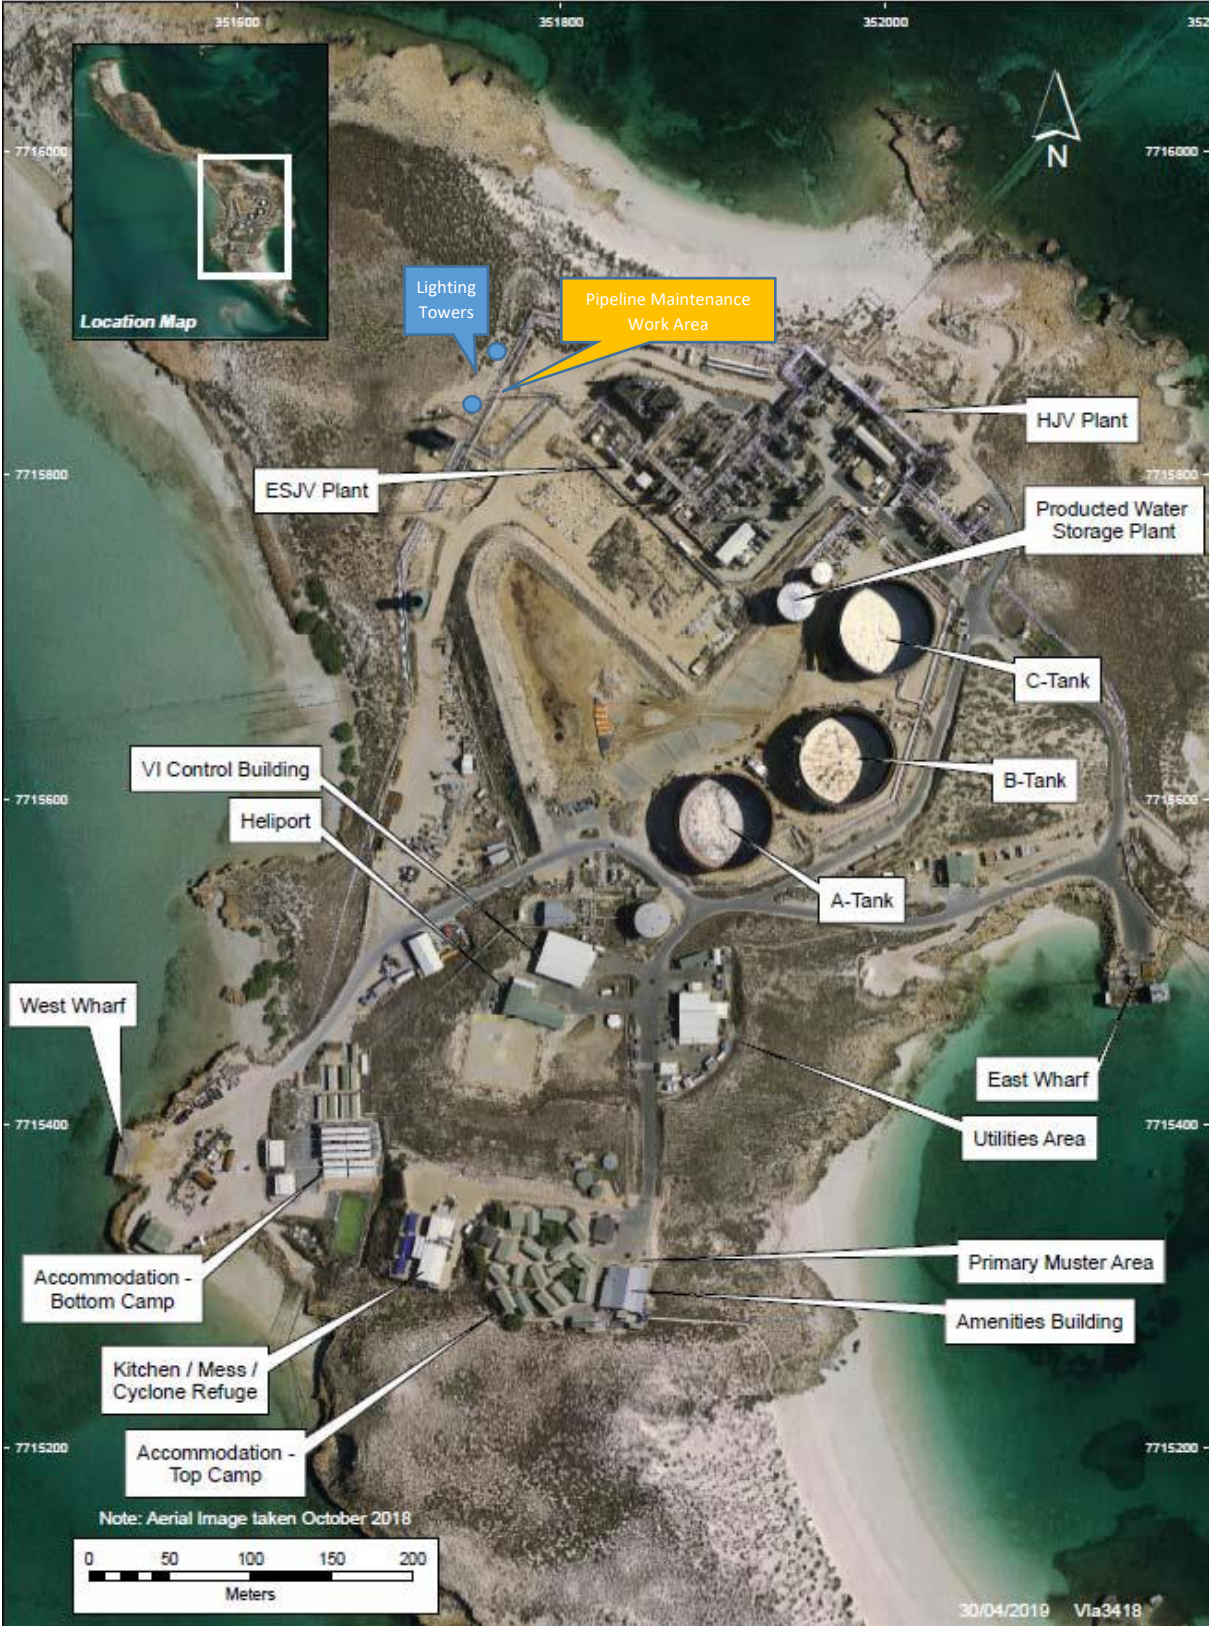
Figure 4-1: Pipeline maintenance work area and proposed location of lighting towers

The location of the proposed activity and lighting tower position is located within the lease area on VI and is shown in **Figure 4-1**.

Two LED directional lighting towers (with 6 x 480W LED lamps) selected for preferential amber colour (least disruptive wavelength) will be used, that can extend to a maximum height (elevation) of 11 m. The amber colour lights have a wavelength of 588 nm. Each lighting tower will be powered by diesel engines. The lighting towers will illuminate the work area around the pipelines to allow 24 hr operations.

The lights will be positioned to meet the lighting objectives of illuminating the work area whilst also preventing light spill outside the work area. Therefore, they will also be:

- + Elevated to the lowest practicable height;
- + Directed down at the work area; and
- + Positioned so that they are facing away from the nearest shearwater rookeries and turtle nesting beaches.

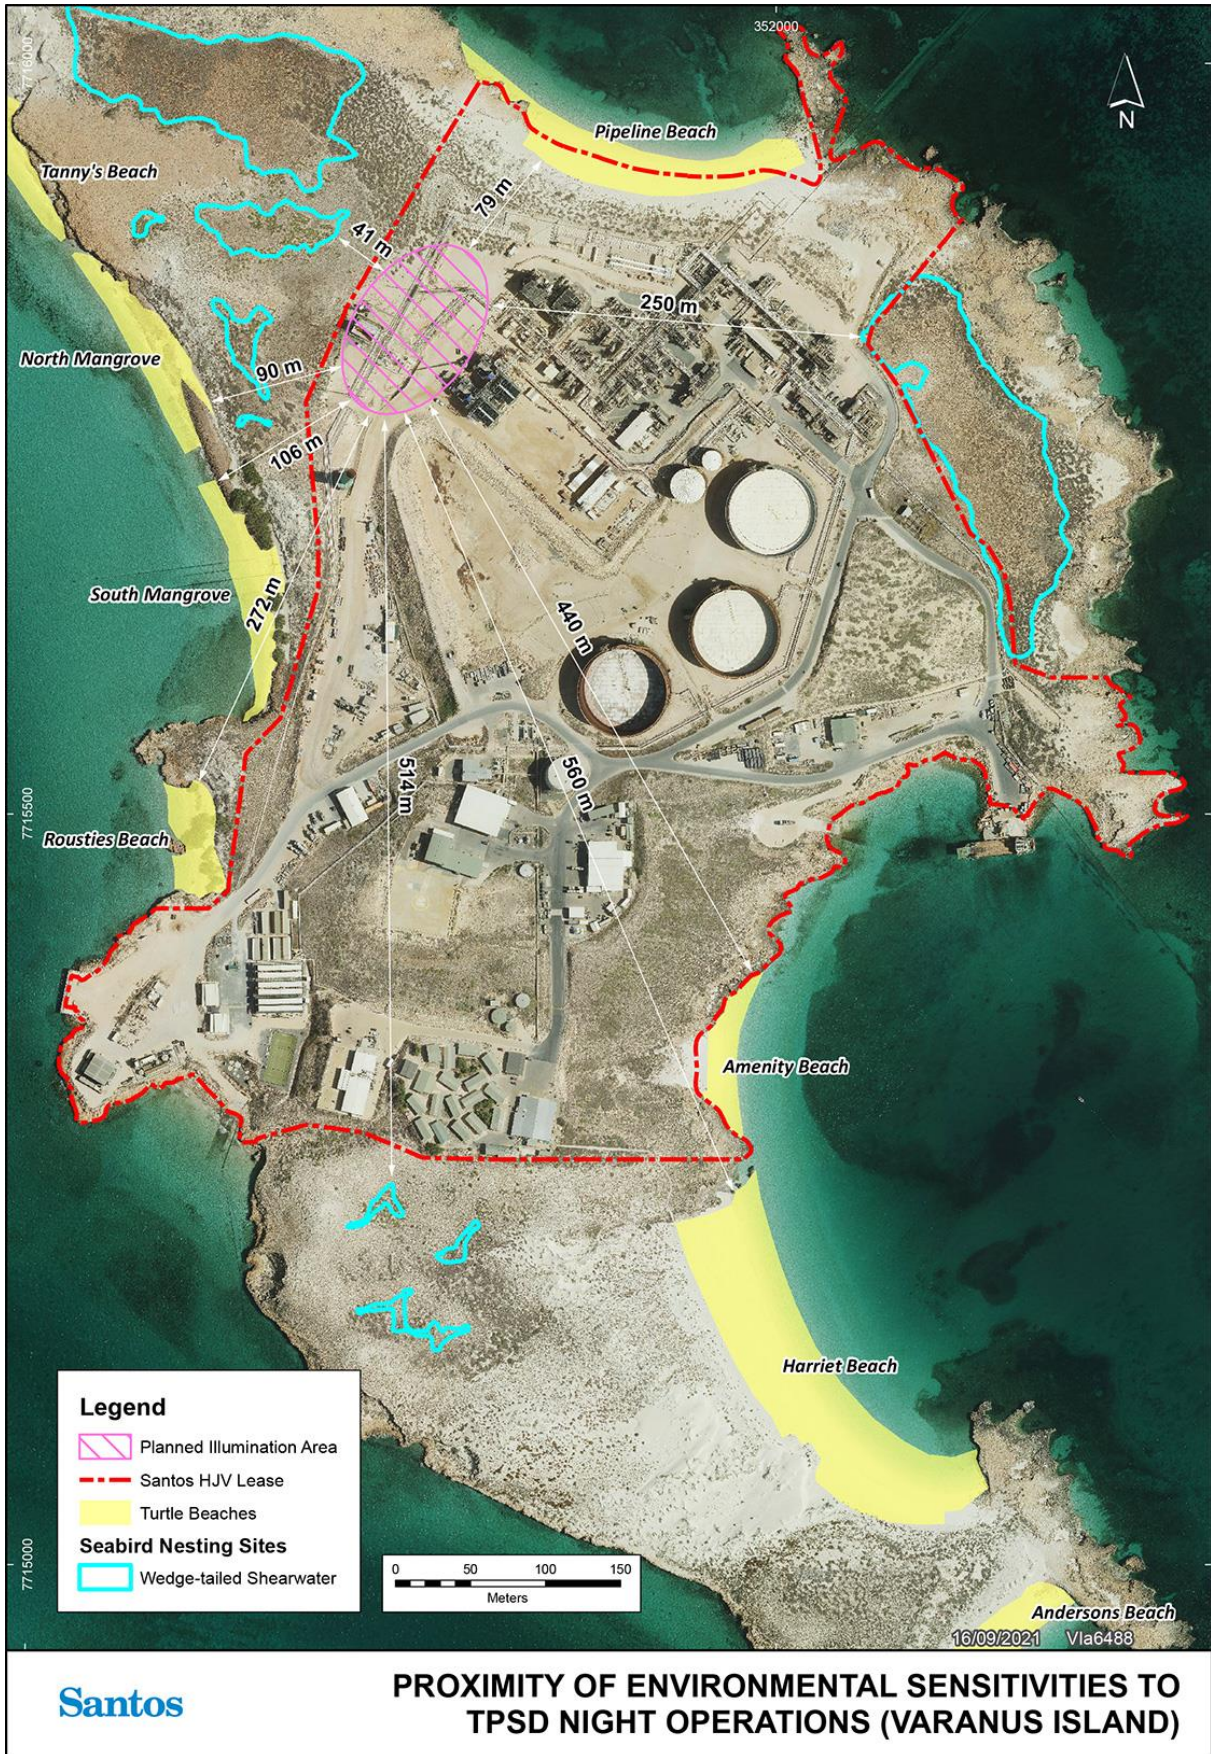
Figure 6-1: Location of environmental sensitivities

The work area is in close proximity to known turtle nesting beaches and shearwater rookeries, with the approximate distances displayed in **Figure 6-1**.

The proposed TPSD activities are approximately 41 m from the closest shearwater rookery (**Figure 6-1**)

The nesting beaches in proximity to the area where the proposed works are include Mangrove Beach and Pipeline Beach, which are approximately 90 m, and 79 m from the work area respectively (**Figure 6-1**). Mangrove Beach is used by nesting flatback turtles (Pendoley Environmental, 2020a), however, to date, there has been very low nesting activity recorded at this location. Pipeline beach is also used regularly by flatback and hawksbill turtles. Historically, hawksbill turtle nesting is expected to peak in October/November and flatback turtle nesting peaking in December/January. Peak hatchling emergence occurs after the ~60 day incubation period in December for hawksbill turtles and February for flatback turtles. Therefore, adult hawksbill turtles may potentially be nesting during the scheduled project works, however the activities will be completed prior to peak flatback nesting or peak hatchling emergence of either species.

Description of the Event	
Environmental Hazard	Artificial light from temporary lighting towers affecting fauna specifically nesting turtles and seabirds (including shearwaters).
Extent	Potential for direct light spill on north-western wedge-tailed shearwater nesting habitat displayed in Figure 6-1 . Potential for additional sky glow visible from turtle nesting beaches displayed in Figure 6-1 .
Duration	For the duration of the activity (10 days)
