**Dampier Bunbury  
Pipeline**

# **PLUTO – NORTH WEST SHELF INTERCONNECTOR**

## **CONSTRUCTION ENVIRONMENT PLAN**

***PUBLIC SUMMARY  
DOCUMENT***

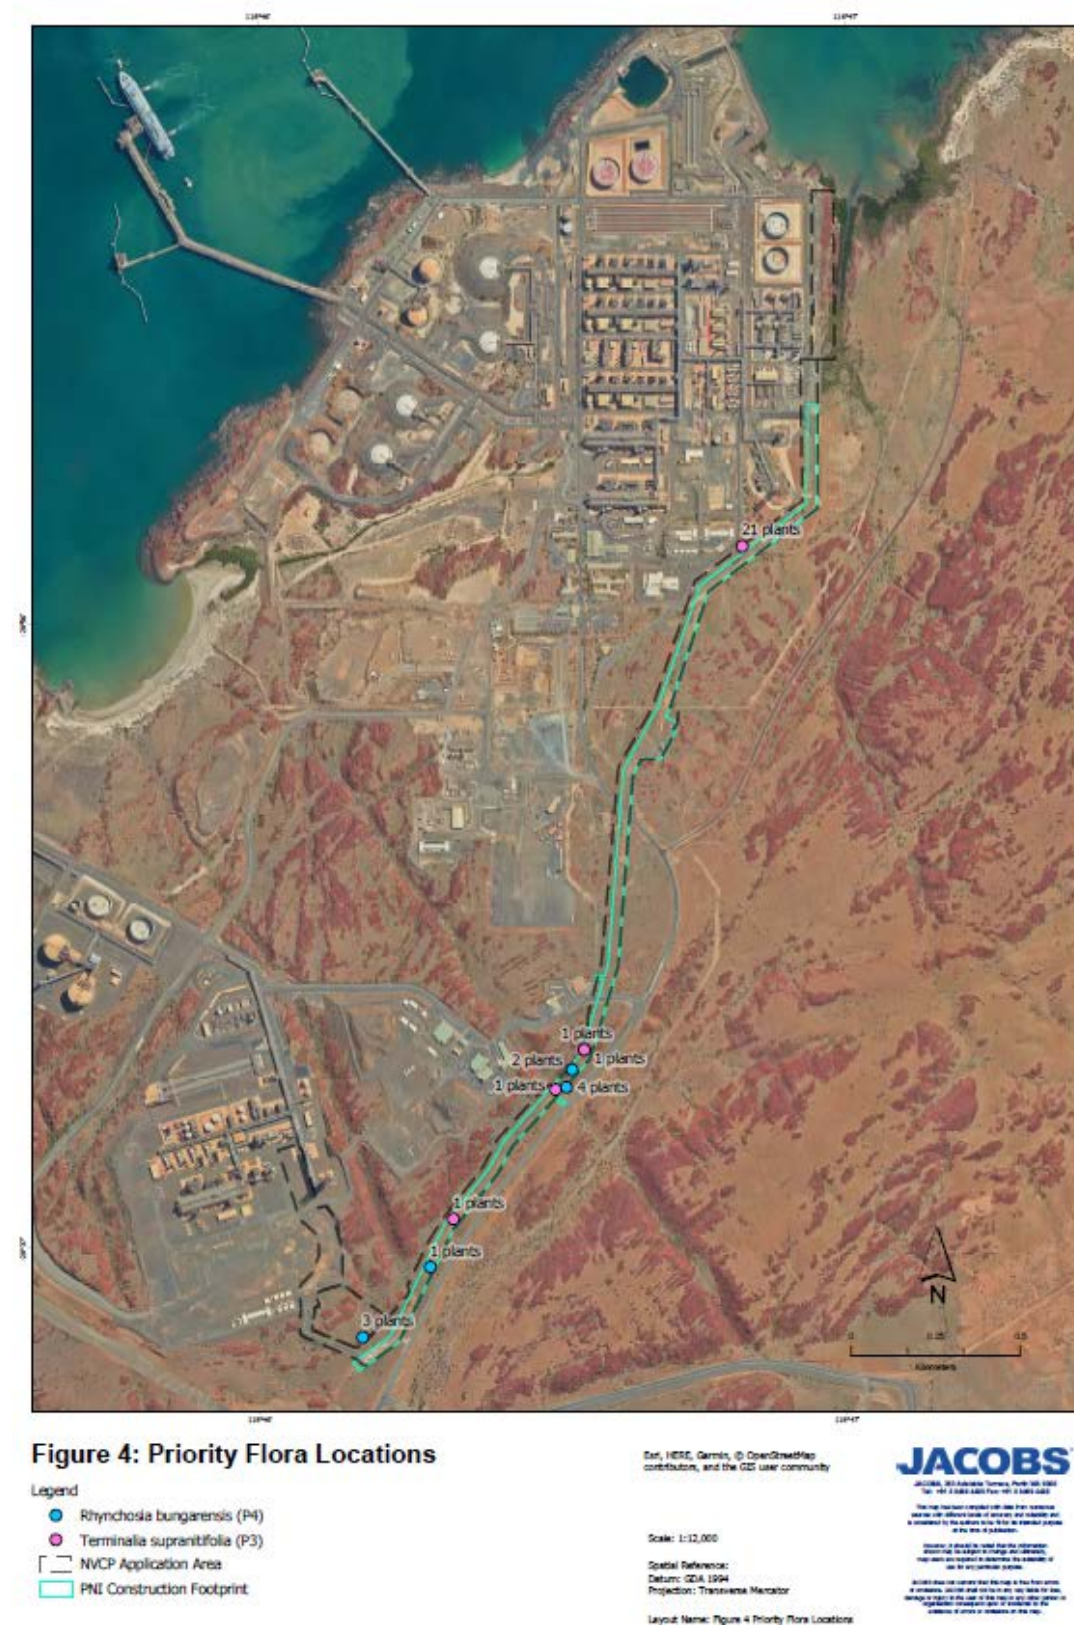
### Figure 4-1 PNI Location and Priority Flora Location

The PNI extends 3.3km along existing pipeline routes to transport natural gas along the previously disturbed pipeline route as shown in Figure 4-1.

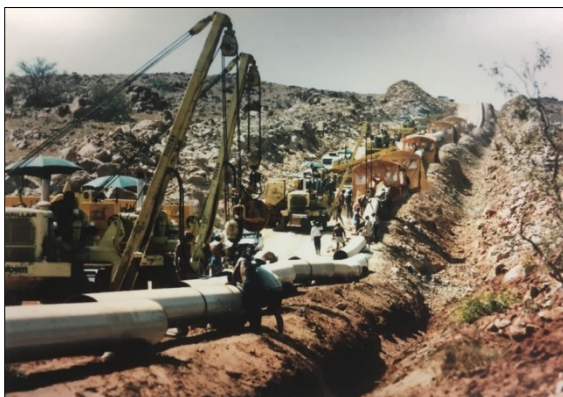
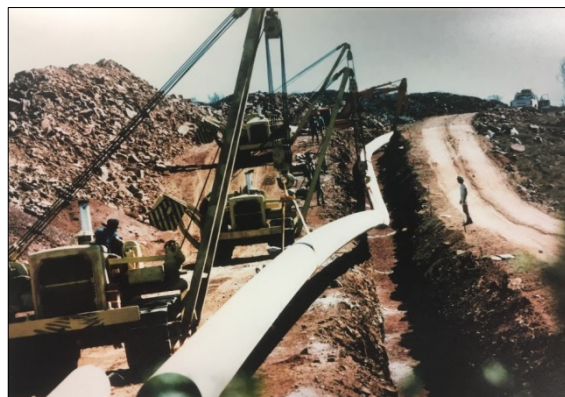
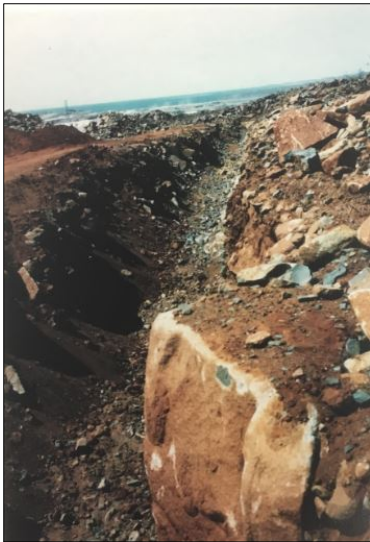
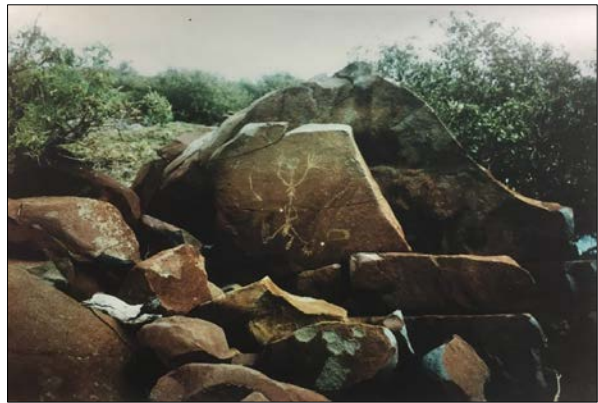
The ultimate size of the Indicative Disturbance Footprint is 10.69 ha. A significant portion of the Indicative Disturbance Footprint is within area of the existing DBNGP (approx. 2.2 km of the length of the PNI), which was constructed in 1982 using blasting and conventional excavation techniques. The DBNGP Corridor has already been disturbed during the construction of the DBNGP as shown in these photographs.

**The Original DBNGP being constructed (where the proposed PNI will be installed) in 1982**
