# Contaminated Sites Remediation Activities Up-scaled Active Remediation via Skimmer Pumps

## Bridging document Summary

**EA-00-RI-10170.01**

| PROJECT / FACILITY | Varanus Island |

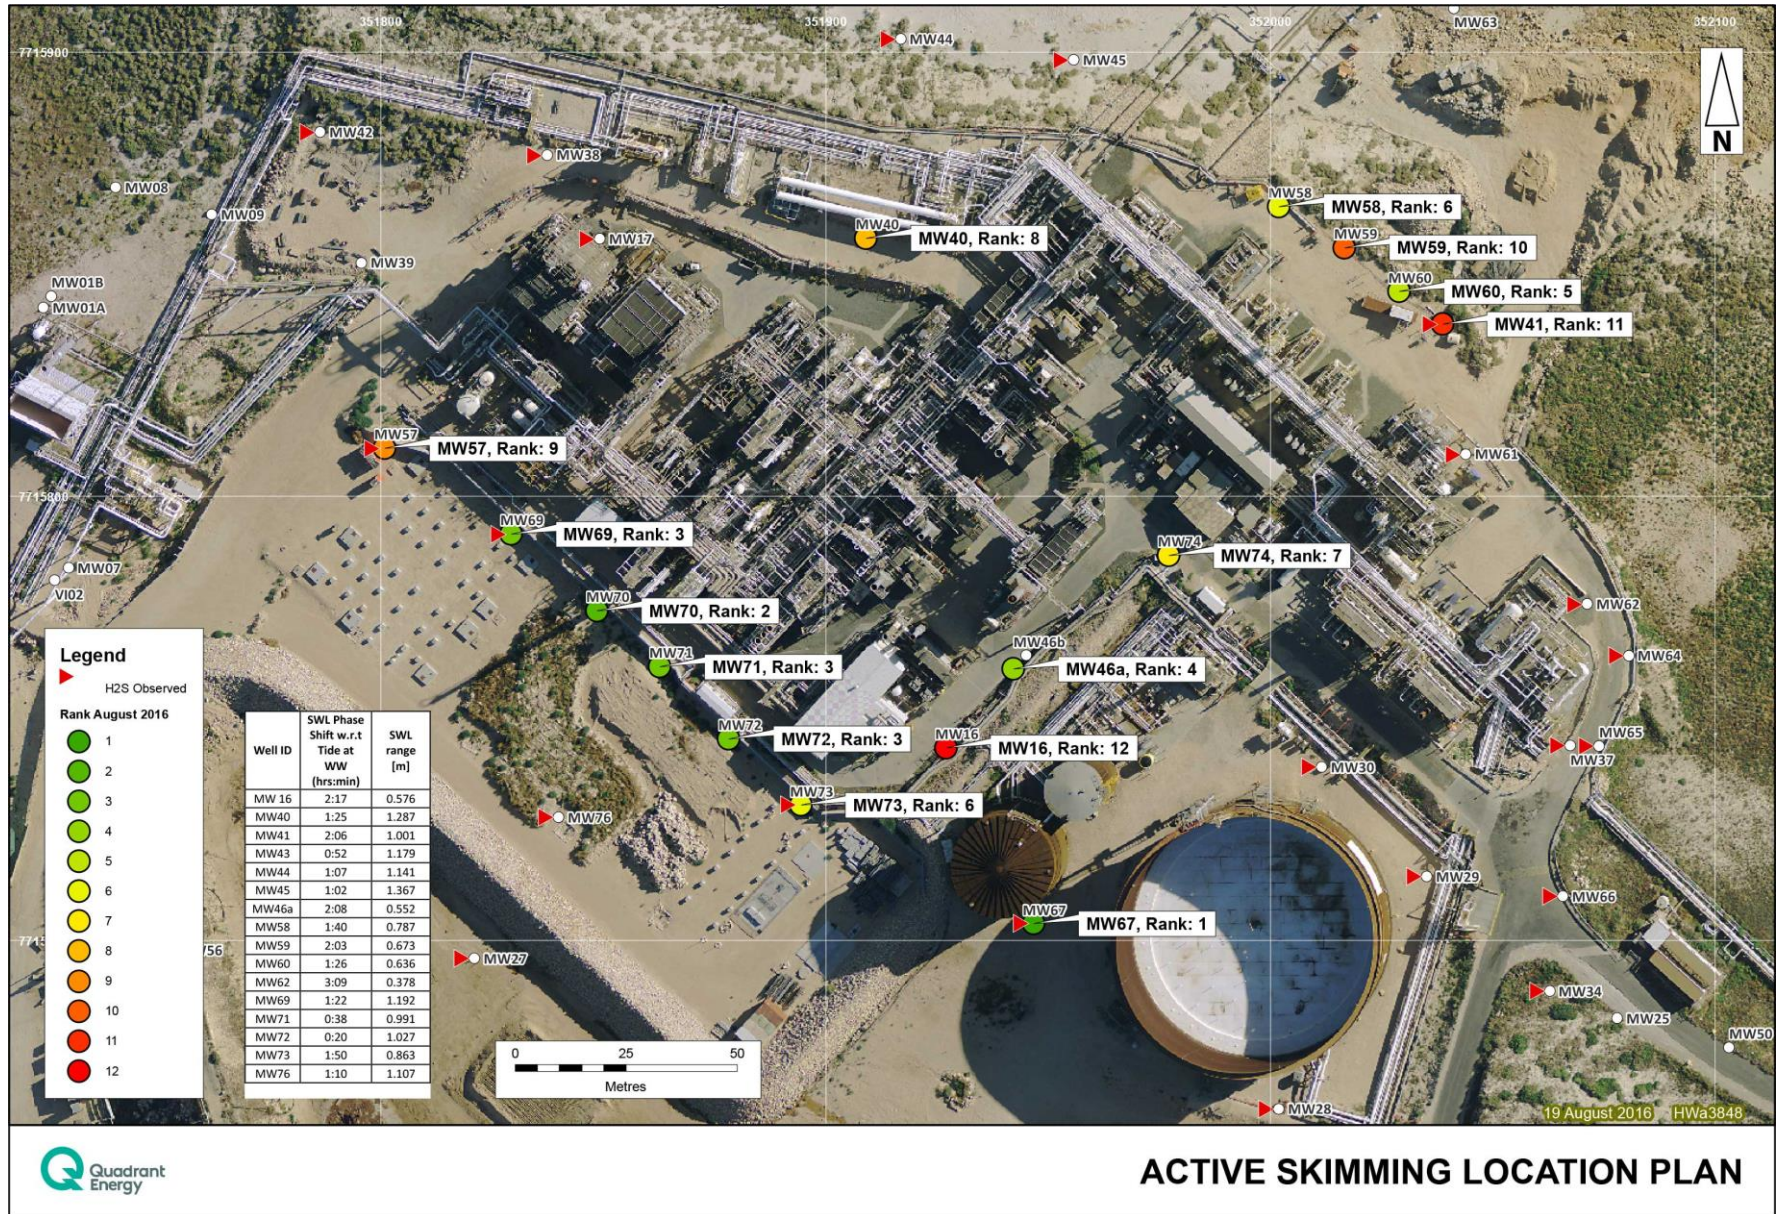
Figure 3-1: Varanus Island Monitoring Well Locations

QE have identified 15 wells that are suitable for skimming and for the deployment of the GeoSorb socks. Dependant on the recovery success at each of the wells, the pumps may be moved from time to time to optimise recovery. Up to 10 pumps may be in operation at any given time. **Figure 3-1** shows the groundwater monitoring wells that may be used for the active skimming and passive removal of LNAPL, and co-ordinates are provided in **Table 3-1**.
